Rehabilitation of 140m of 20" cast iron water main pipe within an urbanised areas, whilst minimising disruption to the community and adjacent buried utilities.

## Thames Water *Whitechapel, London.*

# CAST IRON WATER MAIN

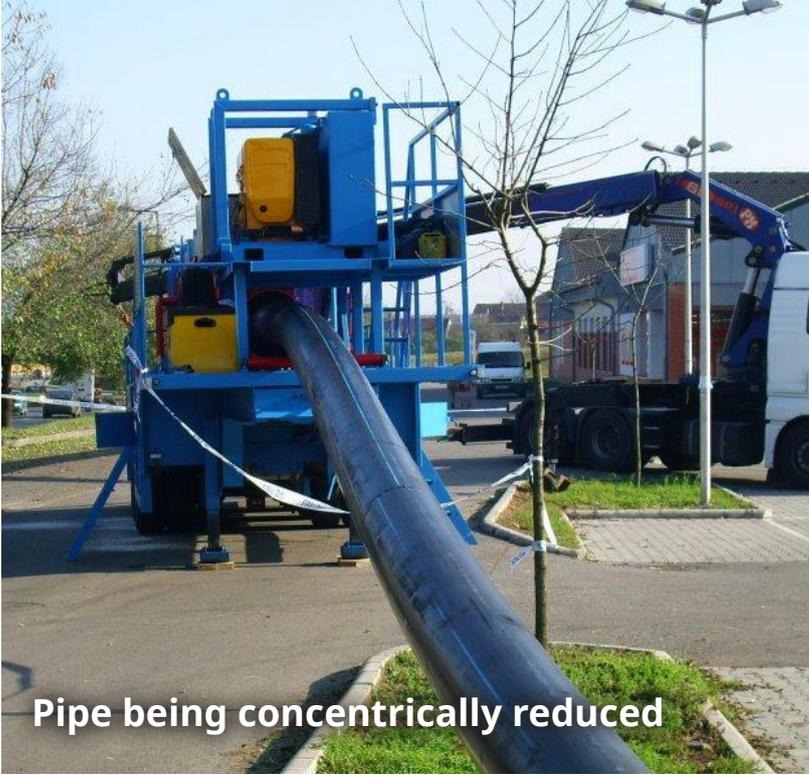
Pipe being concentrically reduced

A fully structural lining for the renovation of weakened and aging pipes, this concentric reduction (reducing diameter by approximately 10%) pipe lining system is thick walled and fully pressure rated with approval for both drinking water and mains gas applications.

As its insertion into the host pipeline uses conventional slipling techniques, only small access trenches are required and once inserted, the pipe is pressurised with cold water to revert it to its original diameter, retaining its capacity and forming a close fit within the host pipe.

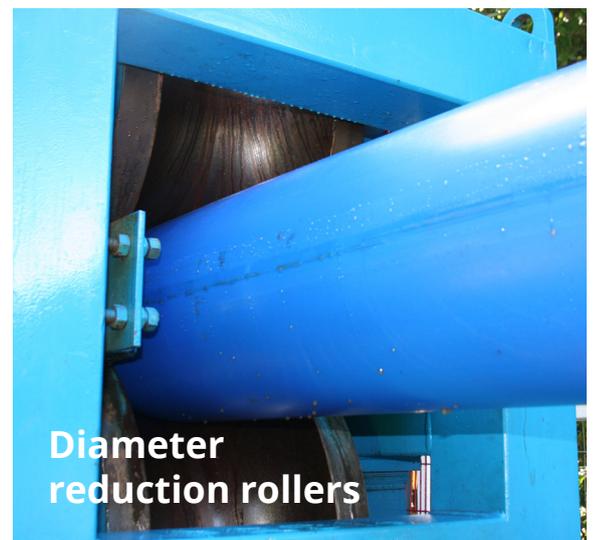
Diameter reduction rollers
